CONSERVATION MANAGEMENT PLAN

for **DICKSON LIBRARY**

prepared by
PHILIP **LEESON** ARCHITECTS PTY LTD

Endorsed by ACT Heritage Council, June 2013

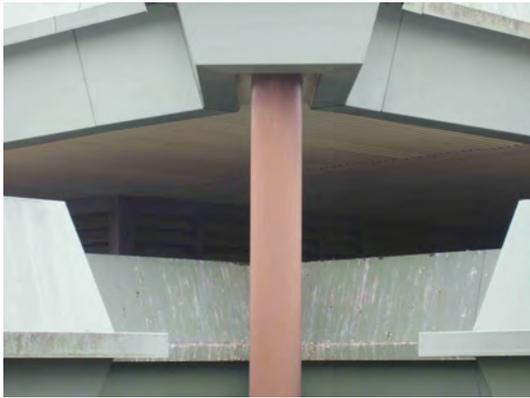
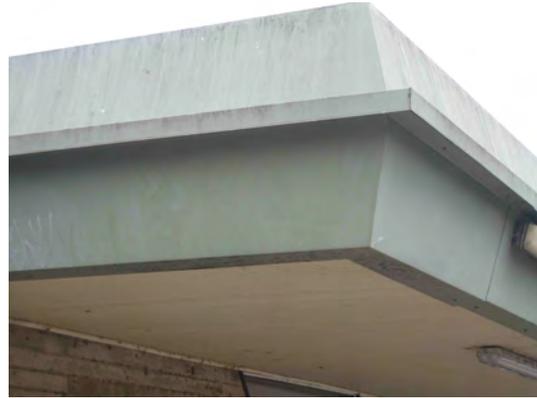
FIGURES 25 & 26 • Detail photographs of profiled Colorbond fascia, downpipes and soffit linings • Source: Philip Leeson Architects.

- Colorbond fascias replace the original asbestos design, but in the same profile
- Colorbond soffit linings replace original caneite soffit linings
- Modern fluorescent light fittings fixed to underside of soffit replace original light fittings, which matched internal fittings
- Original red gloss down pipes repainted brown

1. Pressure clean profiled metal fascias to remove bird droppings
2. Fix anti-roosting devices to ledges of profiled metal fascias
3. Treat rust to circular galvanized sheet down pipes and re-paint in original primary red colour

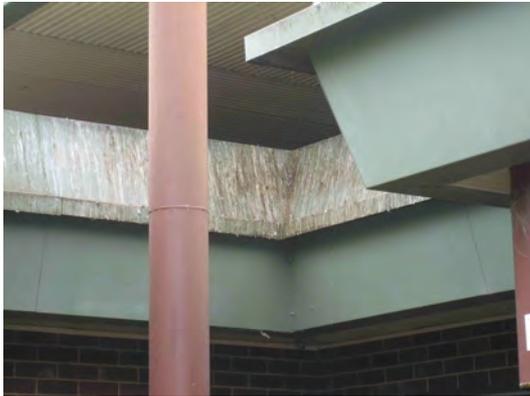
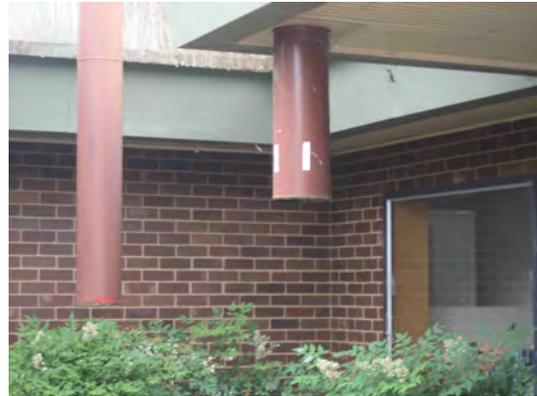
FIGURES 27 & 28 • The roof is thick with bird droppings, as birds roost freely along its perimeter • Source: Philip Leeson Architects. • Downpipes are showing signs of rust, and the top coat of brown paint is peeling to reveal the original primary red paint • Source: Philip Leeson Architects.

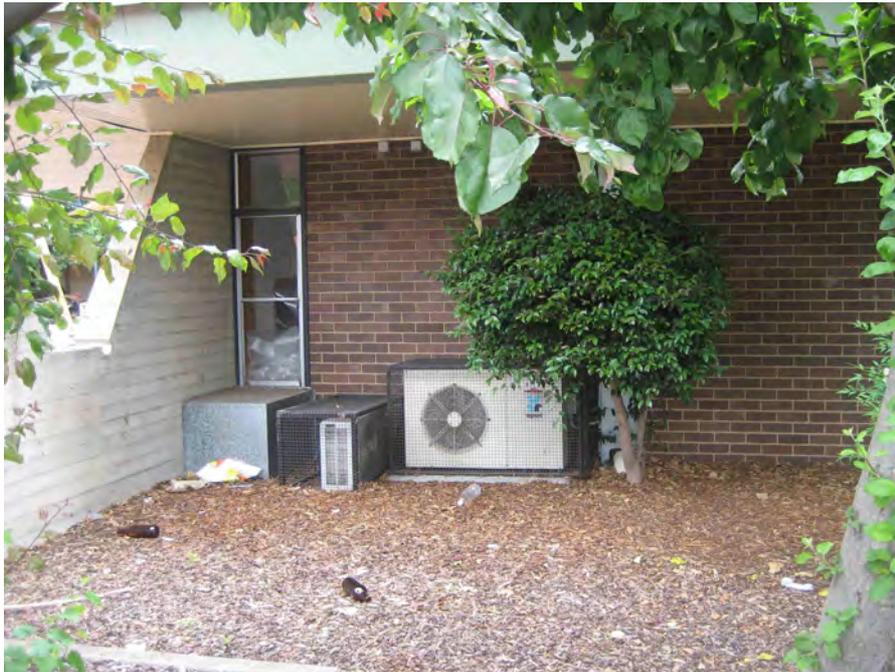
FIGURE 30 • Air conditioning plant and rubbish in the courtyards detracts from the architectural qualities of the place • Source: Philip Leeson Architects.

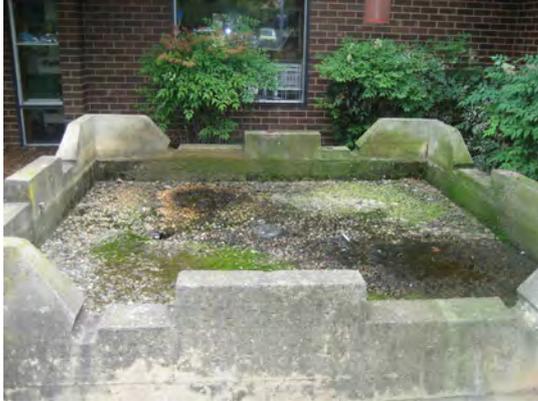
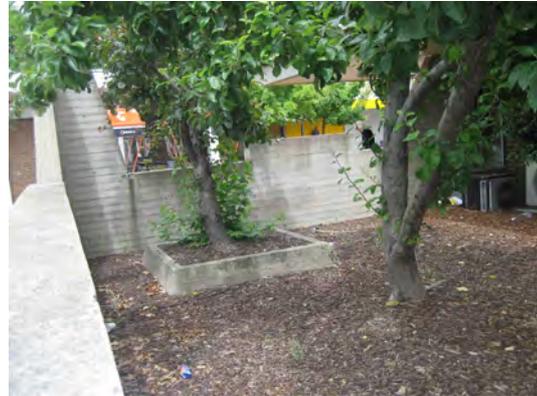
FIGURES 31 & 32 • Sludge and debris has built up in the storm water pond • Source: Philip Leeson Architects.
• Fruiting apple in the foreground is a later planting • Source: Philip Leeson Architects.

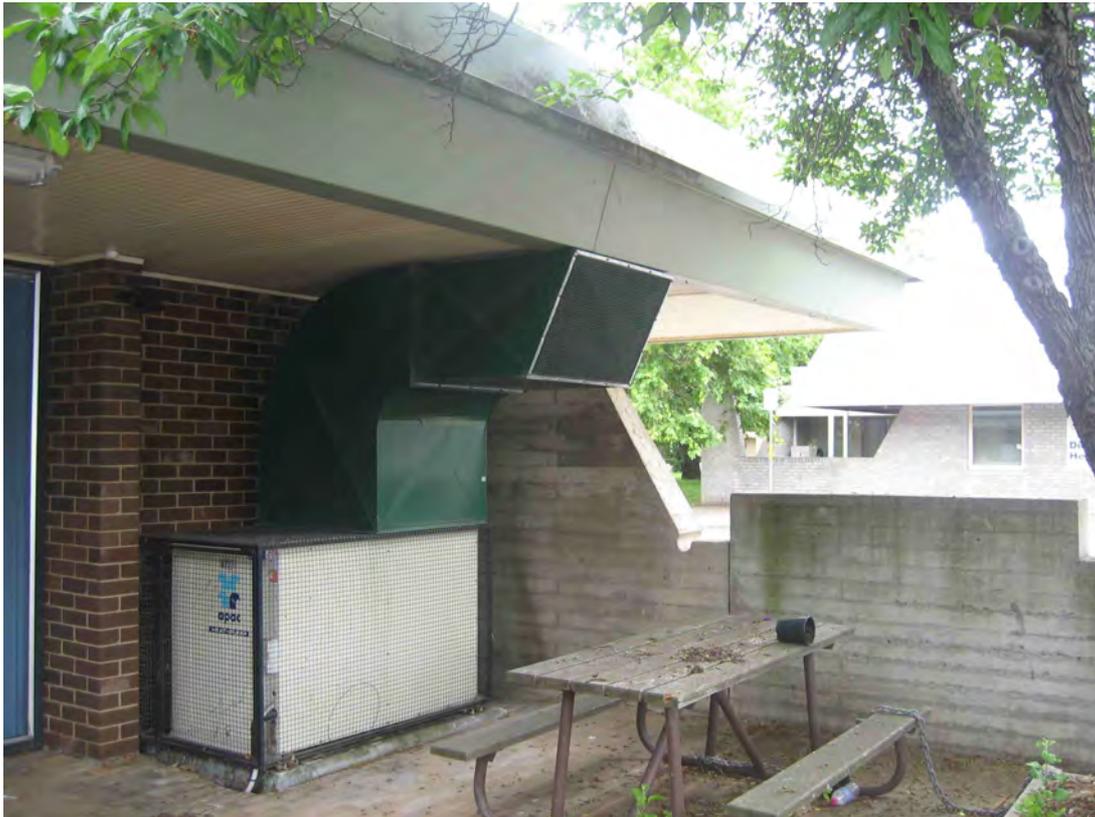
FIGURE 35 • Large air conditioning plant gives the courtyard the character of a service yard • Source: Philip Leeson Architects.

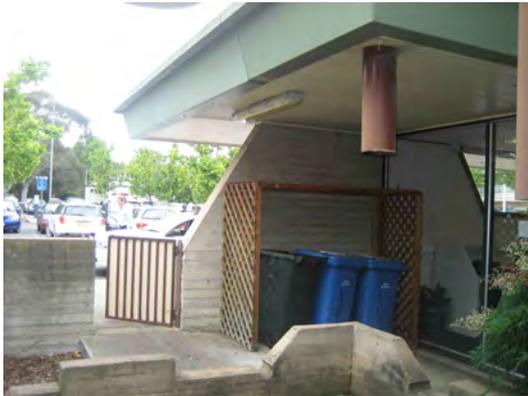
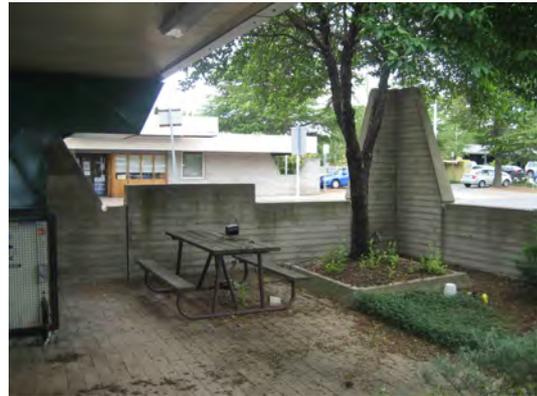
FIGURES 36 & 37 • Part of the original courtyard wall has been removed to allow for the insertion of a gate • Source: Philip Leeson Architects. • The courtyard is partly paved • Source: Philip Leeson Architects.

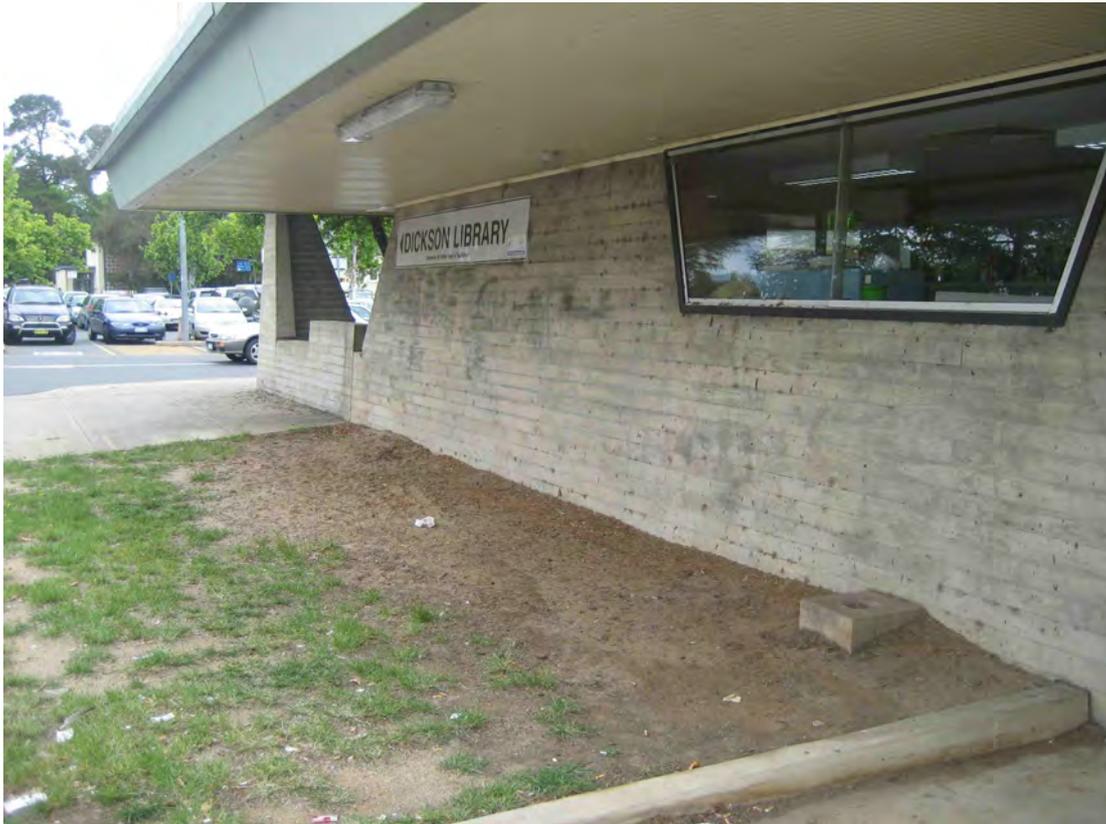
FIGURE 38 • The soft landscaping at the rear of the building has suffered from neglect. • Source: Philip Leeson Architects.

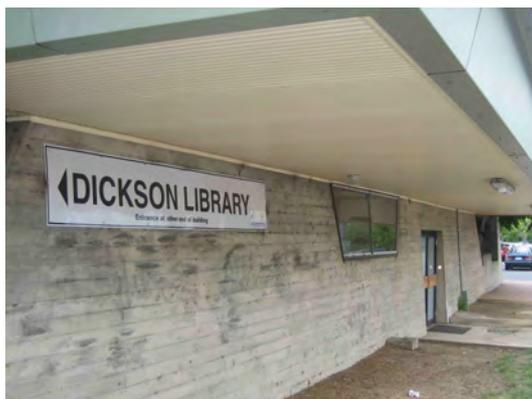
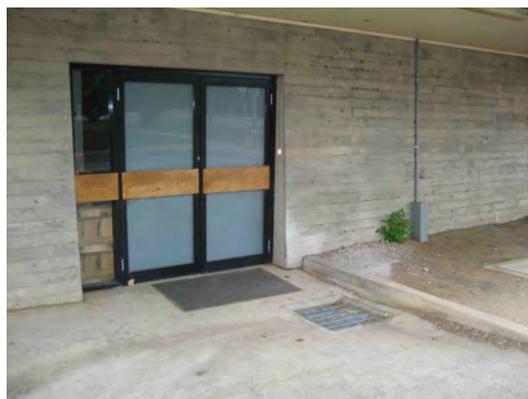
FIGURES 39 & 40 • The rear elevation appears to have suffered from graffiti in the past • Source: Philip Leeson Architects. • The rear service doors are the only doors to display distinctive horizontal handles. The handles are in a cricket bat profile, and are clear finished Ash • Source: Philip Leeson Architects.

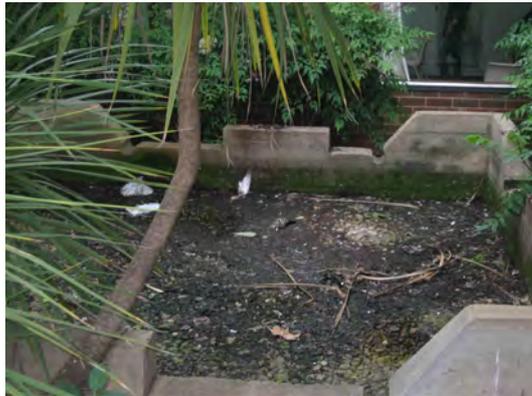
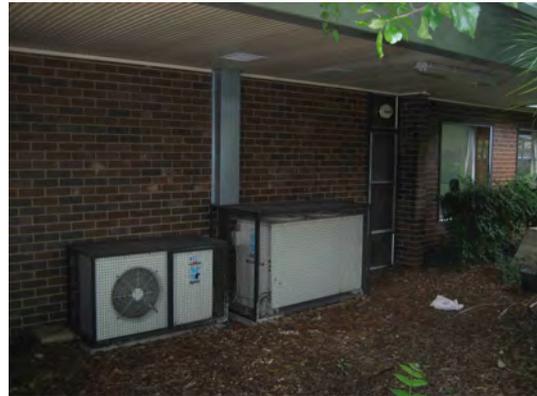
FIGURES 42 & 43 • Sludge and debris have built up in the storm water pond over time • Source: Philip Leeson Architects. • Air handling units and associated conduit in the courtyard • Source: Philip Leeson Architects.

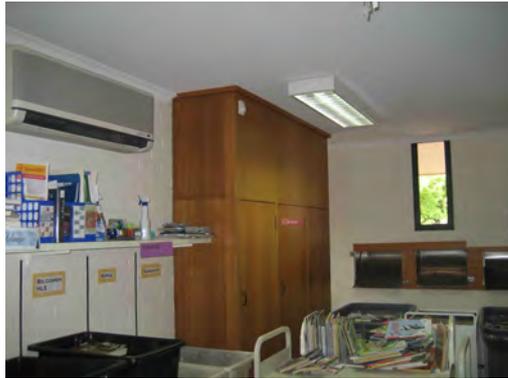
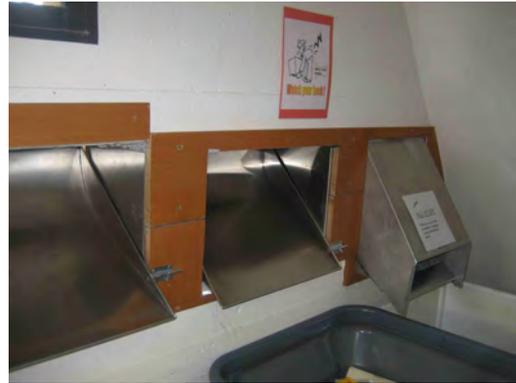
FIGURES 48 & 49 • Returns sorting area • Source: Philip Leeson Architects. • Returns chutes crudely installed in off-form concrete wall • Source: Philip Leeson Architects.

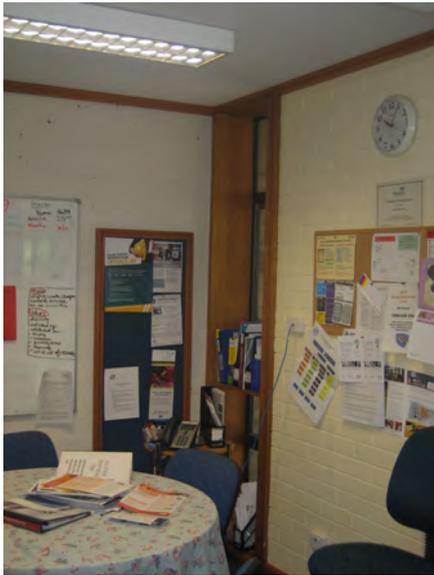
FIGURE 57 • Staff dining / meeting room. Because storage is so inadequate, shelves have been set up in the original window reveal • Source: Philip Leeson Architects.

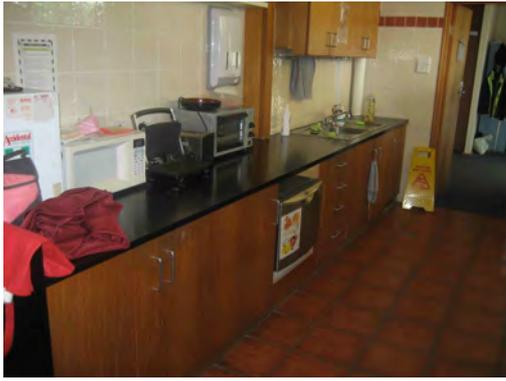
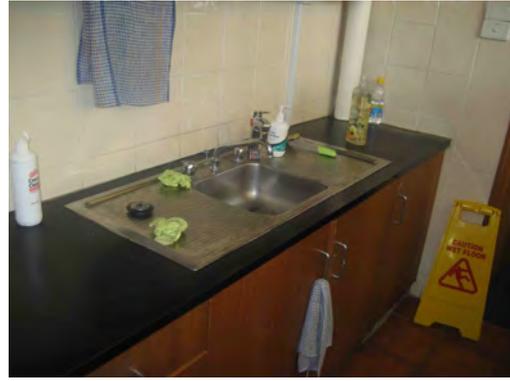
FIGURES 59 & 60 • The kitchenette is not well equipped with storage for appliances • Source: Philip Leeson Architects. • A vent pipe penetrates the bench and is poorly finished at the ceiling • Source: Philip Leeson Architects.

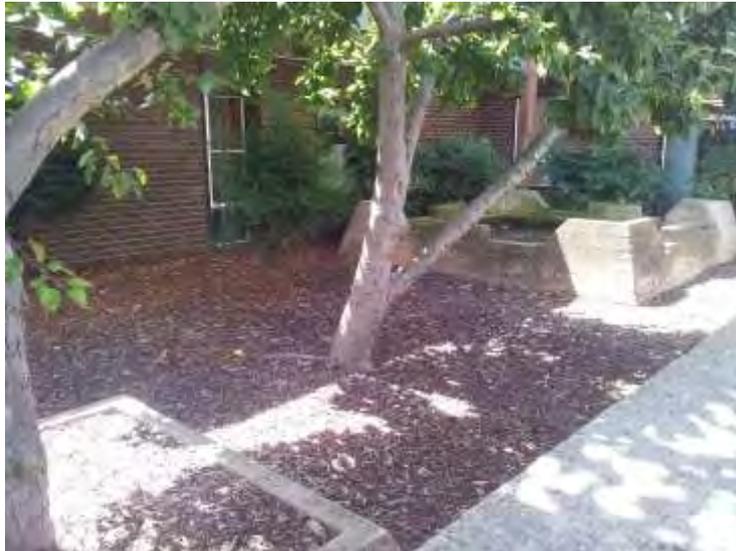
Fruiting Apple is a later planting
Pine Bark mulch is not original and presents a maintenance hazard

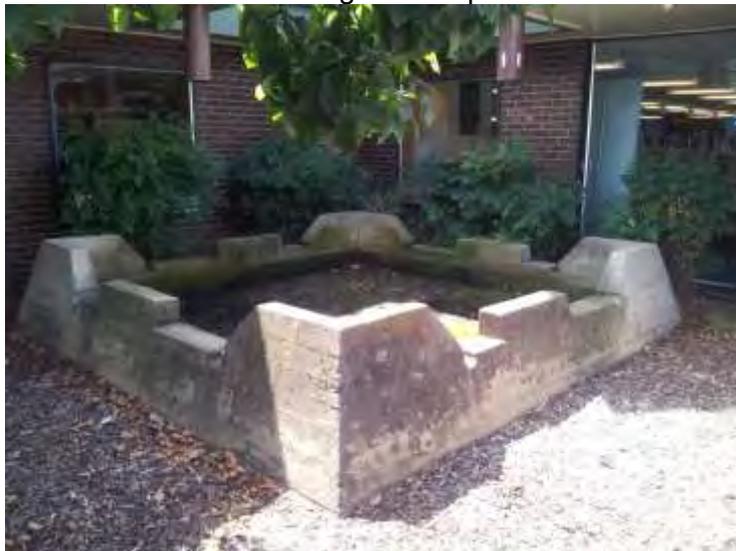
Storm water device requires cleaning to remove loose debris and moss.

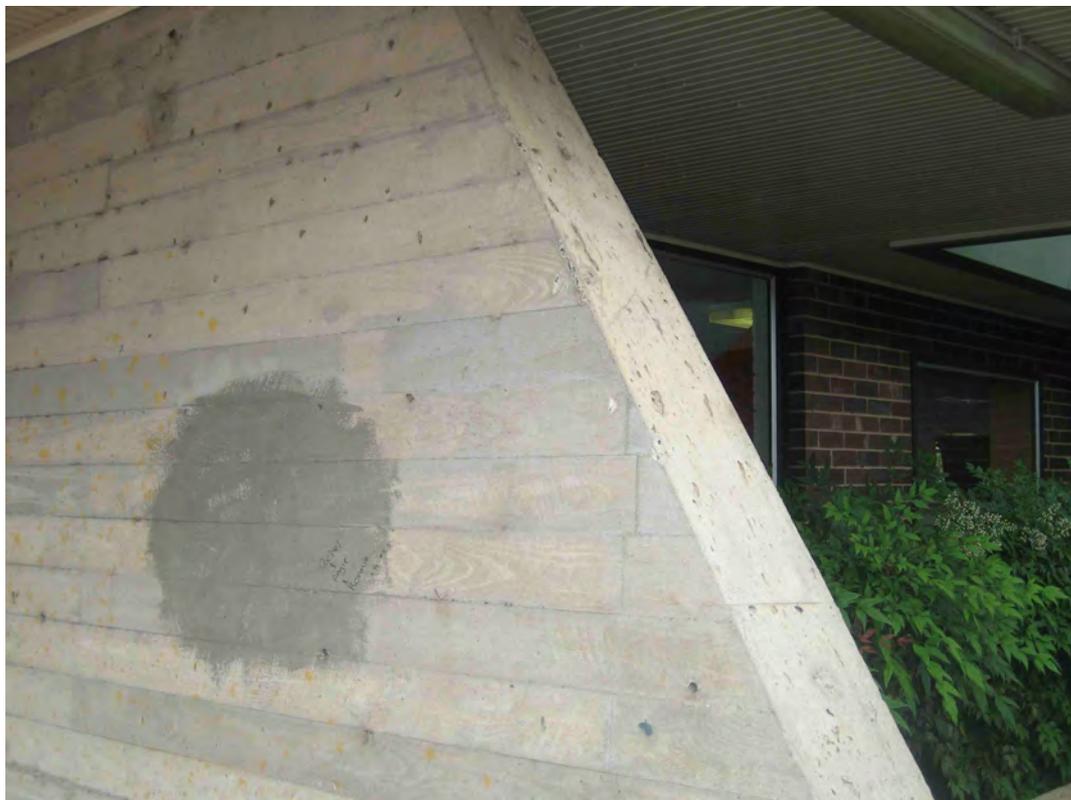
FIGURE 78 • Patches of graffiti on the concrete walls have been painted over unsympathetically in grey paint • Source: Philip Leeson Architects.

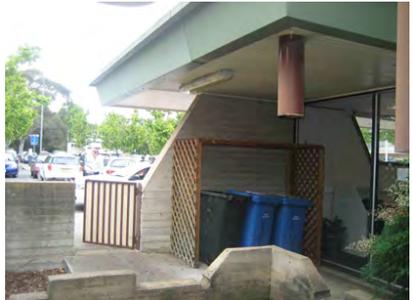
Important	Profiled metal fascias	Pressure clean to remove bird droppings

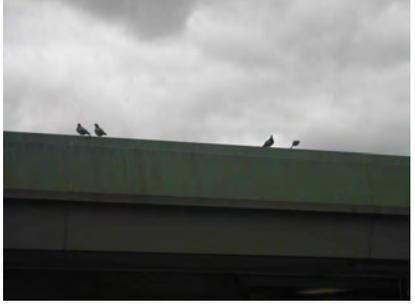
Desirable	Profiled metal fascias	Replace colorbond steel fascias with pre-formed fibre cement sheet to match original details

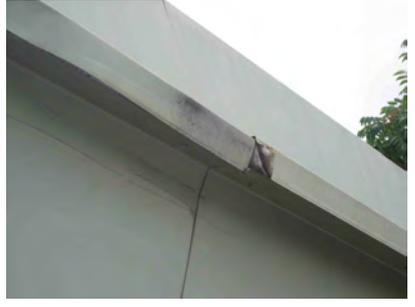
Desirable	Colorbond soffit lining	Replace with fibre cement sheeting to more closely match original painted caneite.

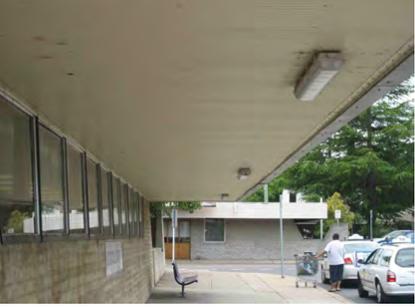
Desirable	External lighting	Replace with fittings more akin to the original lighting design

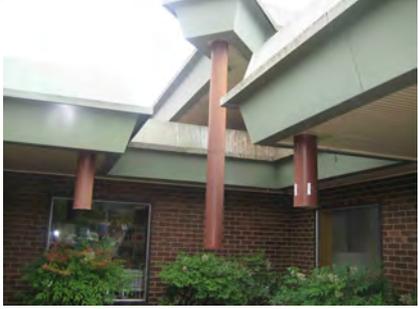
Desirable	Circular galvanised sheet down pipes	Paint in original red colour

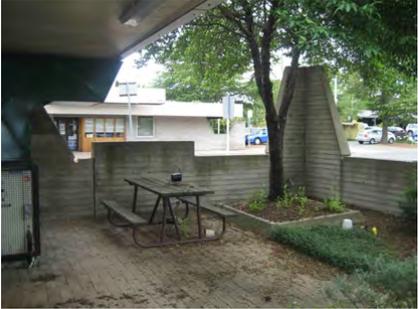
Important	Off form concrete stormwater ponds in courtyards	Remove sludge and debris, pressure clean

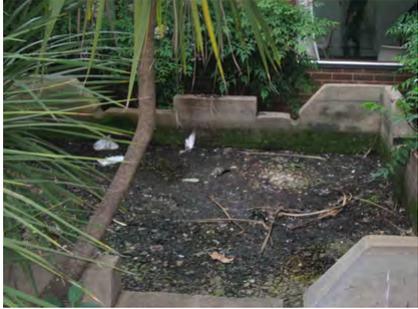
Desirable	Timber mulch and brick paving in courtyards	Replace with concrete unit pavers and / or crushed granite

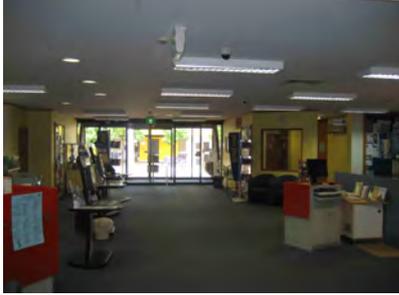
Auto entry doors	Overhaul / replace so not noisy

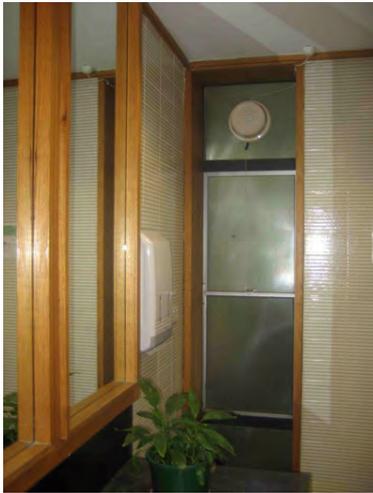
Important	Plasteel windows	Flaking surface on east elevation. Repair with suitable waterproof material.

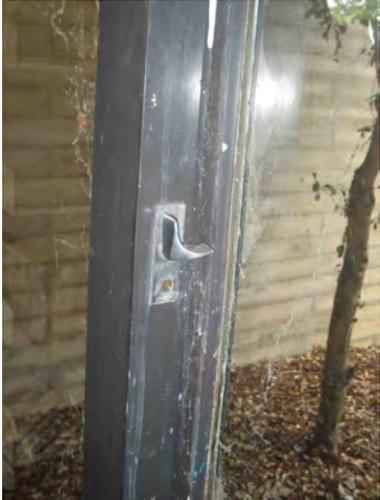
Important	Ash window sills	Worn, water marked. Sand and re-finish. Avoid placing pot plants on sills.	
Desirable	Light fittings	Clean to remove dust and insects

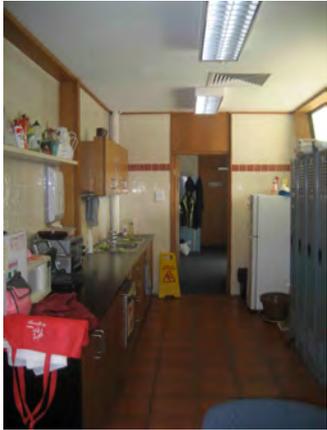
Important	Solid Ash joinery doors in Kitchen	Sand and re-finish
