CONSERVATION MANAGEMENT PLAN

for **DICKSON LIBRARY**

prepared by
PHILIP **LEESON** ARCHITECTS PTY LTD

Endorsed by ACT Heritage Council, June 2013

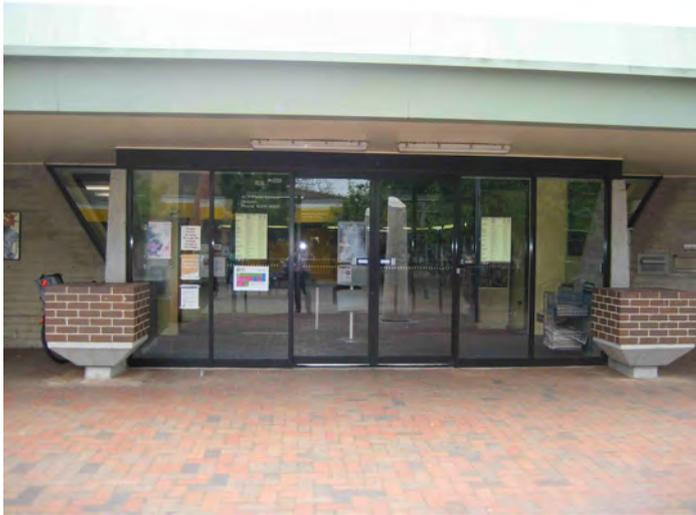
FIGURE 29 • Front entry to the library showing airlock addition forward of original entry • Source: Philip Leeson Architects.

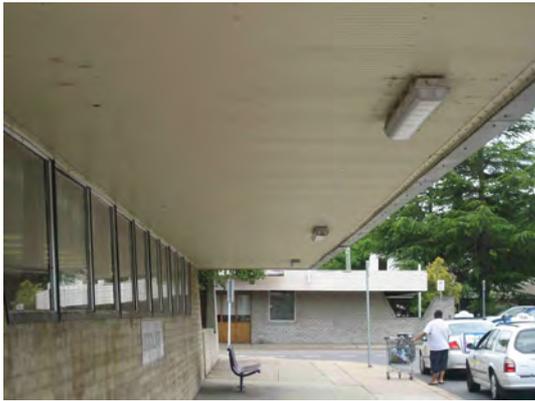
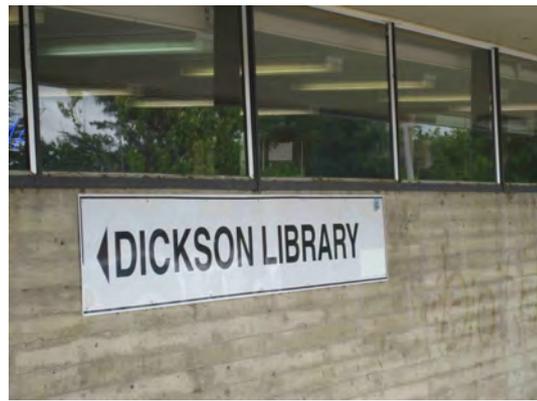
FIGURES 33 & 34 • The deep eave has invited a sheltered space for street furniture and the opportunistic placement of a taxi rank • Source: Philip Leeson Architects. • Later directional signage affixed directly to off form concrete walls. Note the angle of the windows and walls below • Source: Philip Leeson Architects.

1. Pressure clean unpainted off-form concrete walls, and keep an ongoing record of changes to any movement cracking.
2. Sand and refinish clear finished Ash door handles.

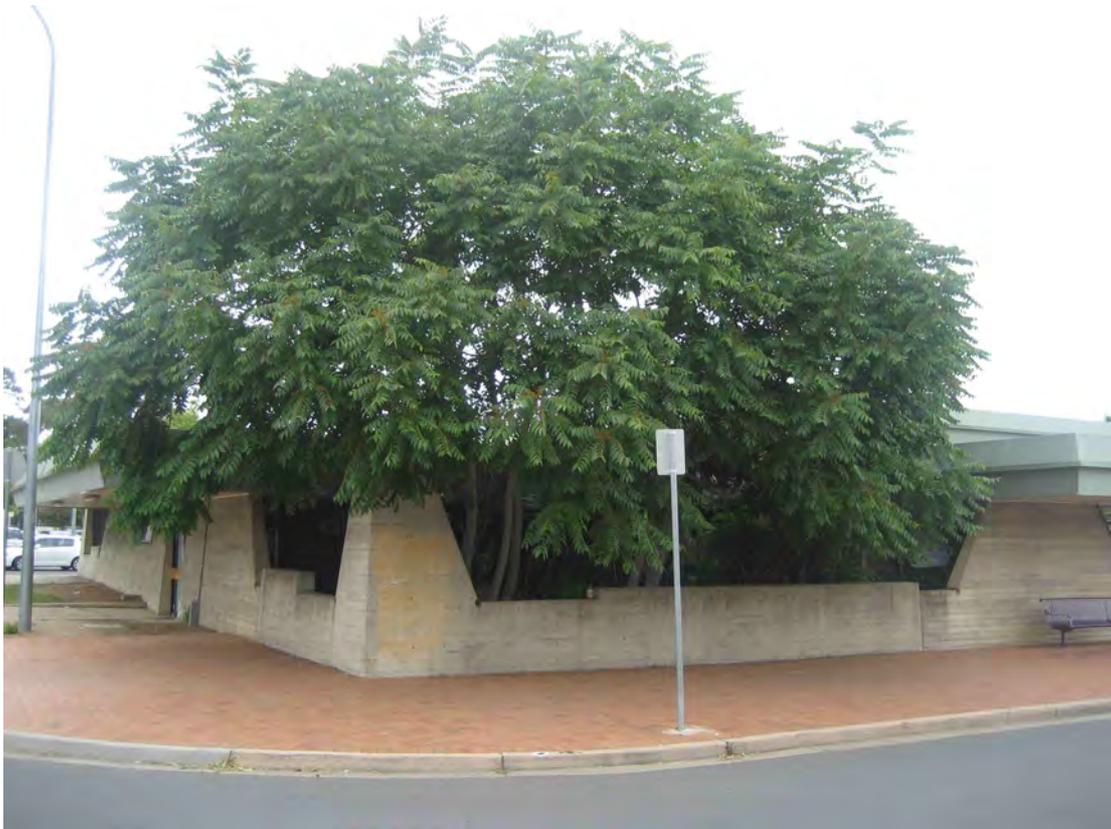
FIGURE 41 • Strong planted character of the northwestern courtyard as viewed from the car park adjacent
• Source: Philip Leeson Architects.

1. Replace timber mulch with concrete unit pavers and/or crushed granite to more closely reflect the original architectural vision
2. Remove air conditioning plant from the courtyard. Install a new system that is not visible on the building exterior.

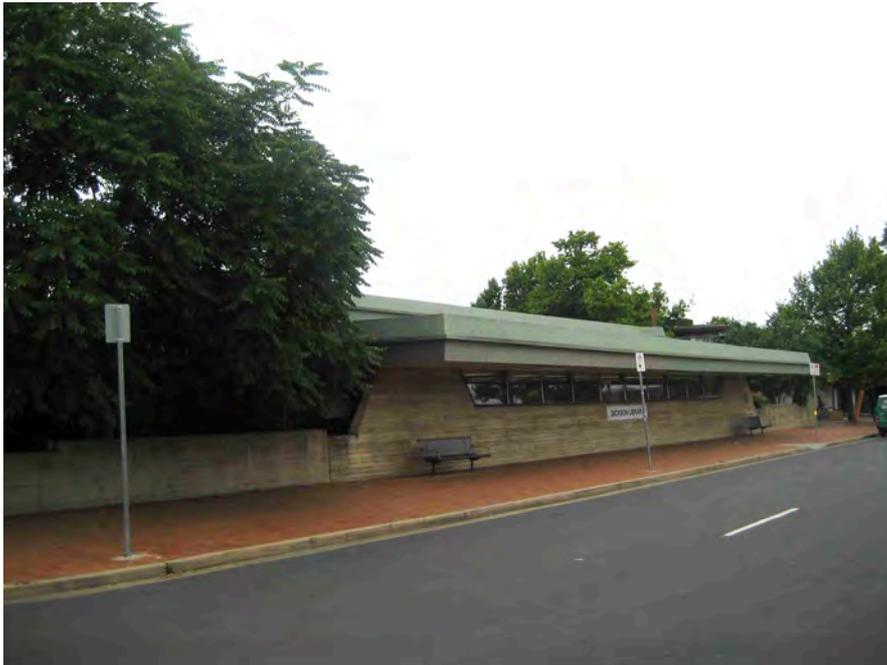
FIGURE 44 • Western elevation of the Dickson Library facing onto the car park • Source: Philip Leeson Architects.

1. Pressure clean unpainted off-form concrete walls, and keep an ongoing record of changes to any movement cracking.

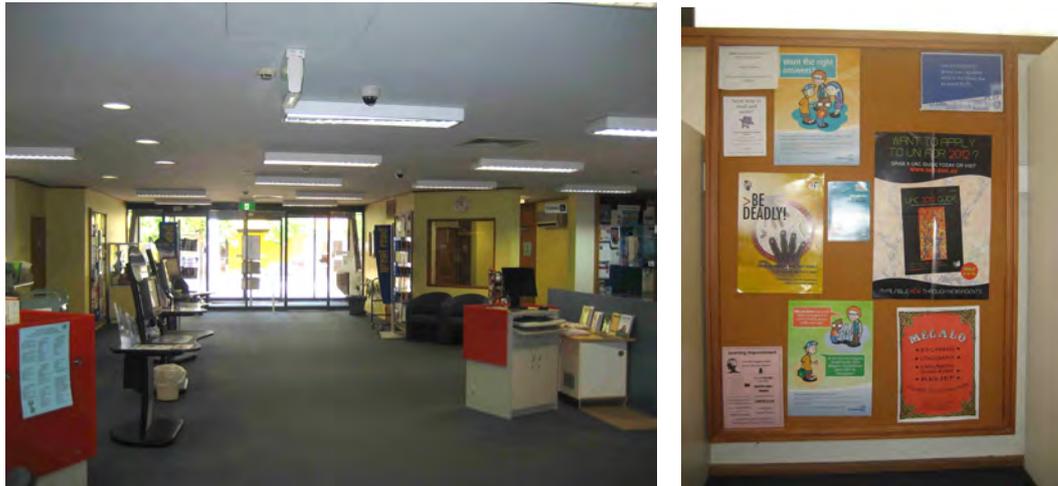
FIGURE 46 • View from main library back, past borrowing terminals, towards entry lobby • Source: Philip Leeson Architects • Ash framed noticeboards from the original fitout have been relocated and are an important source of evidence for any future reconstruction of the interiors • Source: Philip Leeson Architects

1. Replace worn carpet and rubber entry mat.
2. Overhaul or replace sliding automatic entry doors to achieve silent operation.
3. Sand and re-finish clear finished Ash trims
4. Clean glass in windows and doors.

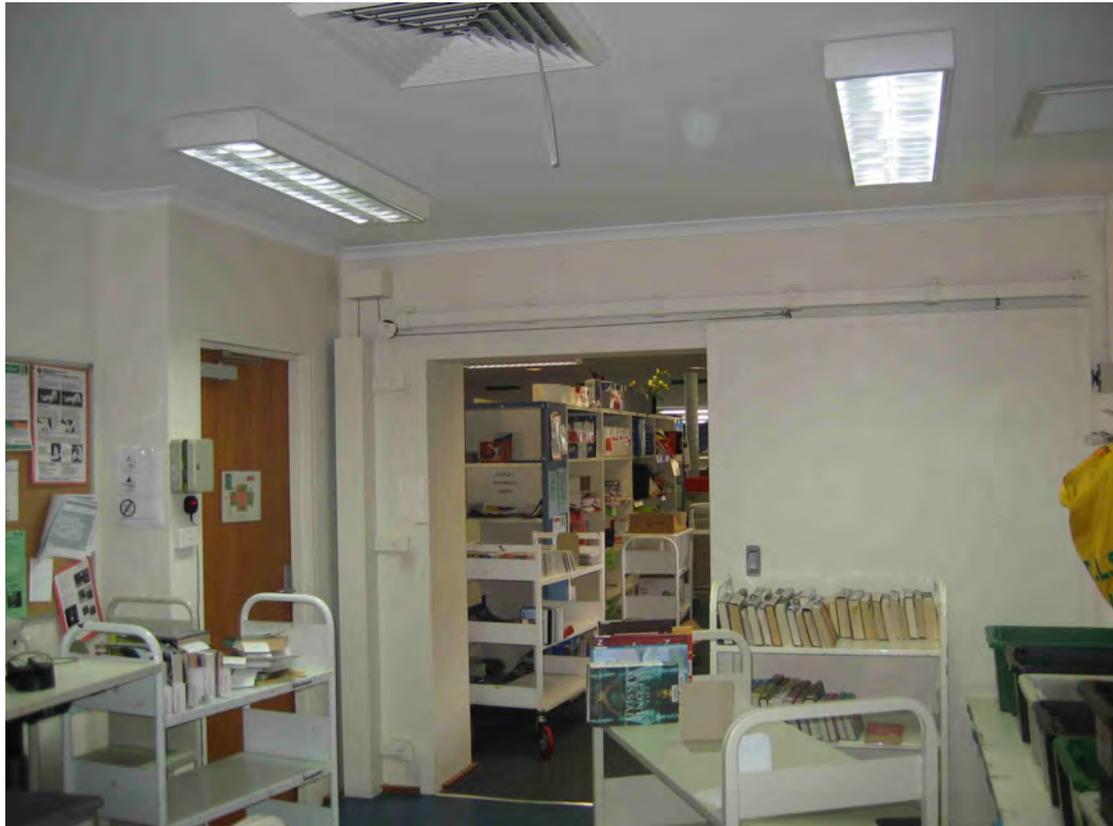
FIGURE 47 • Original sliding fire door now located between main library and returns sorting area • Source: Philip Leeson Architects

- Paint and after hours returns chutes to original off-form concrete wall
- Paint to original face brick walls
- Internal brick walls removed (prior location visible)
- New lightweight wall (1996?)
- New painted plasterboard ceiling with plain coved plaster cornice, lower than original
- Vinyl flooring (1996?)
- Modern ceiling vent, wall mounted air conditioning unit and main switchboard in Ash cupboard

1. Repair poor edge trim carpentry to returns chutes in keeping with the integrity of the place.
2. Clean glass at windows.

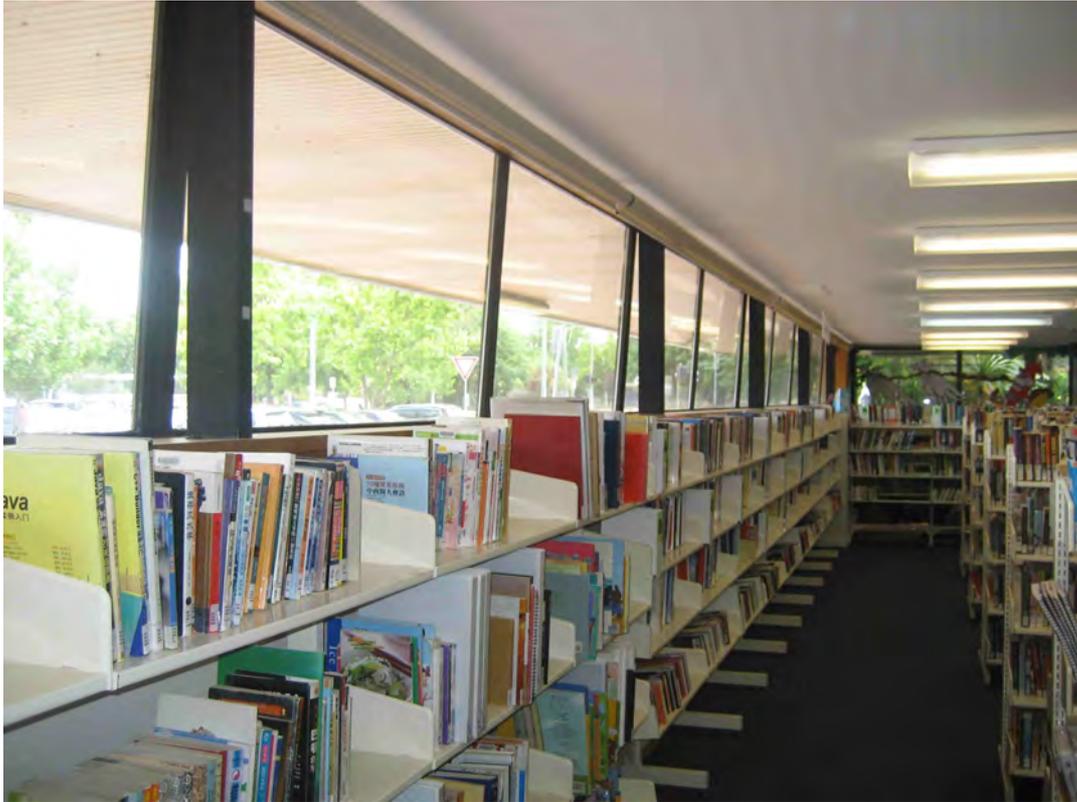
FIGURE 50 • High-level windows. Note the slope on the windows and the steel columns carrying the load from the roof • Source: Philip Leeson Architects.

Fixed windows and sliding doors to each of the four courtyards and to the street are black plastic coated steel or plasteel. Some hardware has been replaced or is missing. Windows to the courtyards have clear finished Ash timber sills. Windows to the street elevations at the east and west are slightly angled out to match the angle of walls at the exterior, and black painted steel RHS columns carry the structure from the roof to the concrete walls below. Modern roller blinds have been installed to the high level windows at the east and west facades.

1. Repair flaking surface to Plasteel windows at eastern side of library with suitable waterproof material.
2. Overhaul Plasteel sliding doors to all courtyards to ensure smooth operation. Replace multi-panel glazing at door to northeast courtyard with single large pane.
3. Sand and refinish worn and water marked Ash windowsills. Avoid placing pot plants on sills.

1. Retain original door and window hardware. Replace later fittings to match originals as closely as possible.
2. Clean large central light feature to remove dust and insects.
3. Sand and refinish clear finished Ash trims, doors and sills.
4. Clean glass at windows and doors.

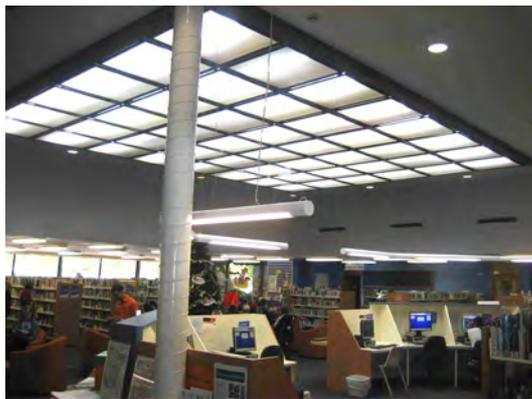
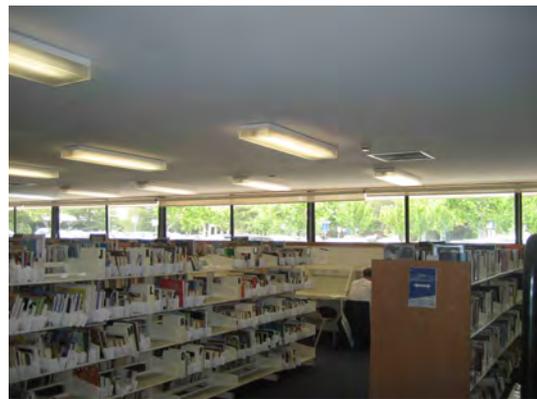
- Mezzanine removed – new suspended timber floor with carpet tiles and floor to ceiling ventilation risers installed (2001)
- Bookshelves, book display, card catalogue, noticeboard, reception desk etc. joinery removed (2001)
- Face brick walls with ironed mortar joints painted (2001)
- Off-form concrete walls painted (2001)
- Lightweight walls added to divide off staff offices (2001)
- H columns rendered and painted (2001)
- Carpet replaced (2001)
- Light fittings removed and replaced (2001?)
- External door hardware damaged and replaced (progressive)
- Modern cable trays, ventilation grilles, smoke detectors, security detectors installed (2001)

FIGURES 51 & 52 • Raised area of ceiling over the centre of the main library where the mezzanine once stood • Source: Philip Leeson Architects. • The internal fitout of the library is modern, and most light fittings have been changed to generic fluorescent type fittings • Source: Philip Leeson Architects.

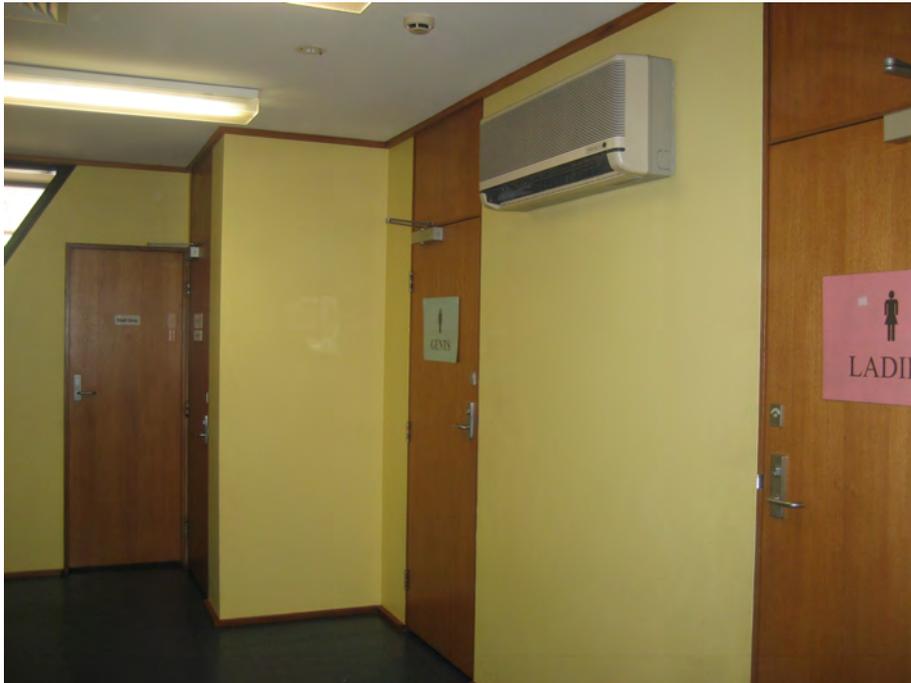
FIGURE 53 • Lobby to public toilets added in 2001 • Source: Philip Leeson Architects.

1. Refurbish original anodised aluminium window to address corrosion and sticking. If replacement is required, match existing as closely as possible.

1. Sand and refinish clear finished Ash trims, doors and sills.
2. Clean glazing at windows.

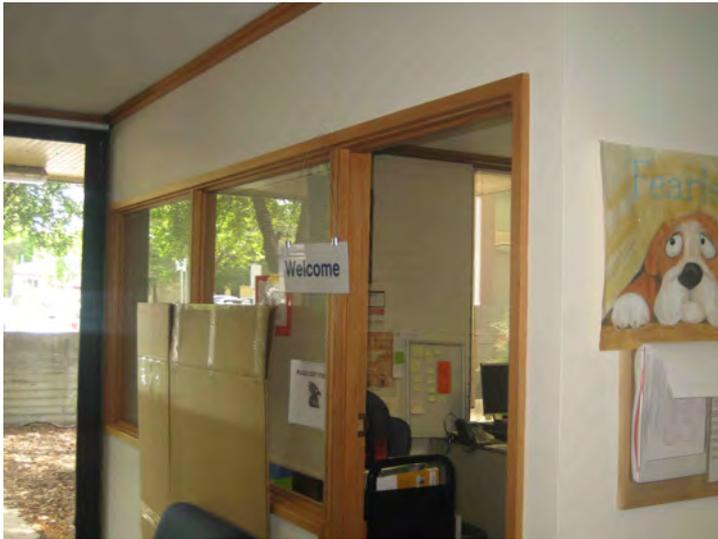
FIGURE 54 • 2001 partitioning used to create staff offices • Source: Philip Leeson Architects.

- Carpet tiles
- Painted dry pressed bricks with ironed mortar joints at external walls (Original brickwork, modern paint)
- Lightweight construction at walls to new offices and main library. Painted plasterboard lining (2001)
- Painted plasterboard ceiling with manhole access hatch (2001)
- Clear finished Ash timber Trims (jambs, cornice, sill) (2001 trims to match original)
- Semi-hollow core clear finished timber doors to offices (2001 to match original)
- Ceiling mounted powder coated white framed light fitting with acrylic diffuser (Original)
- Smoke detectors and fire exit sign (Likely 2001)
- Vertical blinds at sliding door (2001?)
- Built in cupboard. Clear finished Ash timber framed doors with infill MDF panels. (Original Ash timber framing, new infill panels)

1. Replace MDF infill panels at Ash cupboard with Ash veneered board.
2. Sand and refinish clear finished Ash trims, doors and sills.
3. Clean glazed windows and doors.

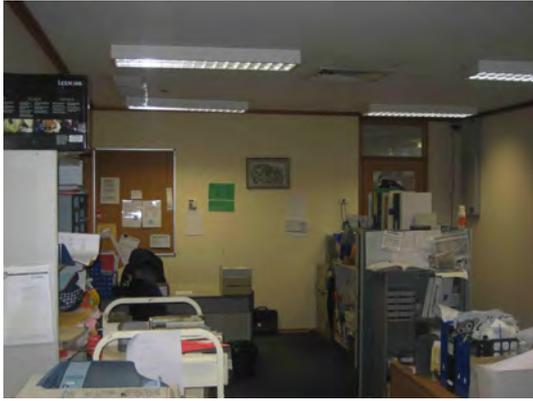
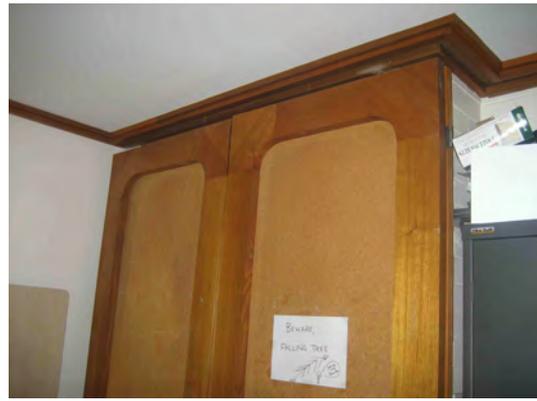
FIGURES 55 & 56 • Open plan staff office area created in 2001 and largely used for ad hoc storage •
Source: Philip Leeson Architects. • Original joinery unit adapted with unsympathetic MDF infill panels •
Source: Philip Leeson Architects.

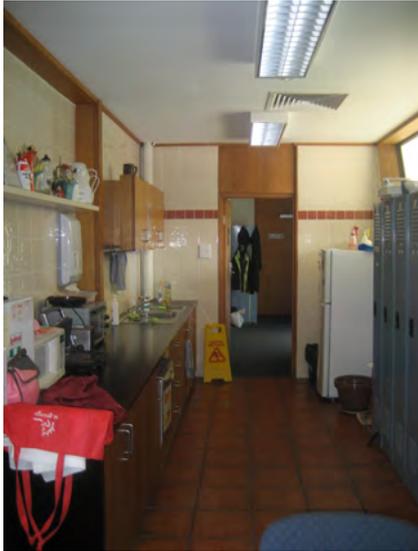
FIGURE 58 • Staff kitchenette • Source: Philip Leeson Architects.

- Off-form concrete walls have been painted
- Former servery opening has been infilled and tiled, and a new shelf has been installed (2001)
- Ceramic wall tiles and terracotta floor tiles replace original (2001)
- Kitchen joinery has been modified for new appliances. The oven has been removed, and a dishwasher, microwave and instant hot water tap have been installed
- Modern services have been added such as air conditioning grilles, smoke detectors and ceiling mounted powder coated white framed light fitting with acrylic diffuser

1. Sand and refinish solid Ash joinery doors in kitchenette.
2. Seal black laminate bench top against wall to prevent water ingress.
3. Repair poorly patched ceiling at vent pipe penetration at kitchenette.

1. Replace unsympathetic ceramic floor and wall tiles in kitchenette with new tiles or with linoleum at floor to match original architectural character.
2. Provide adequate storage for kitchen appliances. Devise a more sympathetic storage arrangement for staff personal items and remove lockers.
3. Sand and refinish clear finished Ash trims, doors and sills.
4. Clean glazing at windows.

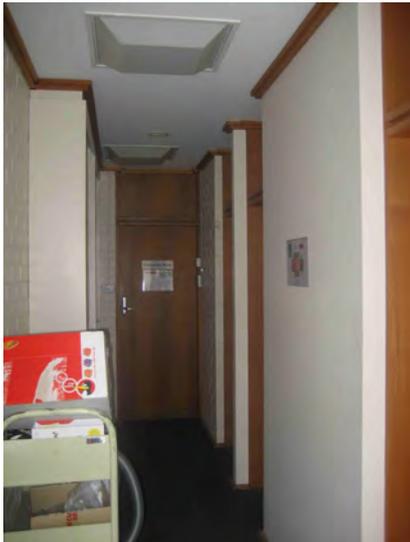
FIGURE 61 • View from staff lobby past staff toilets showing existing brick walls (now painted) and new plasterboard walls. New doors and trims match original detailing, and light fittings are original • Source: Philip Leeson Architects.

1. Sand and refinish clear finished Ash trims, doors and entry door handles.
2. Clean glazed windows and doors.

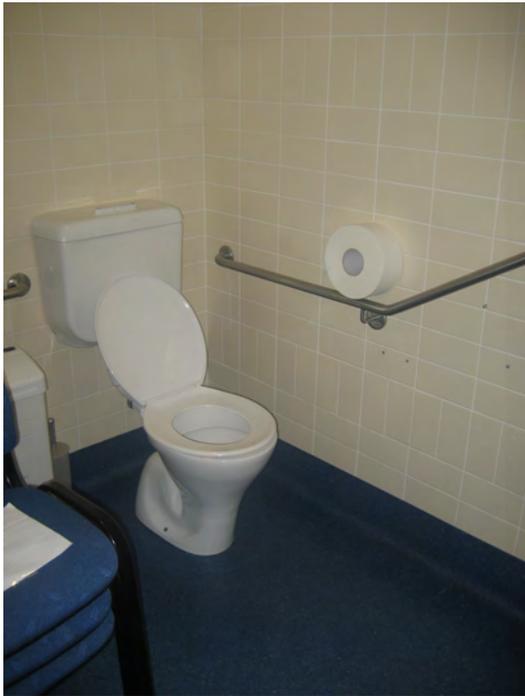
FIGURE 62 • Staff and community room disabled access WC upgraded in 2001 • Source: Philip Leeson Architects.

1. Refurbish original anodized aluminium windows to address corrosion and sticking. If replacement is required, match existing as closely as possible.

1. Replace Masonite in the lower panel of the anodized aluminium window with obscure glazing to match original.
2. Remove window mounted exhaust fan and replace glazing to match original. Install ceiling exhaust fan so as to conceal from the exterior of the building.
3. Sand and refinish clear finished Ash trims, doors and sills.
4. Clean glazing at windows.

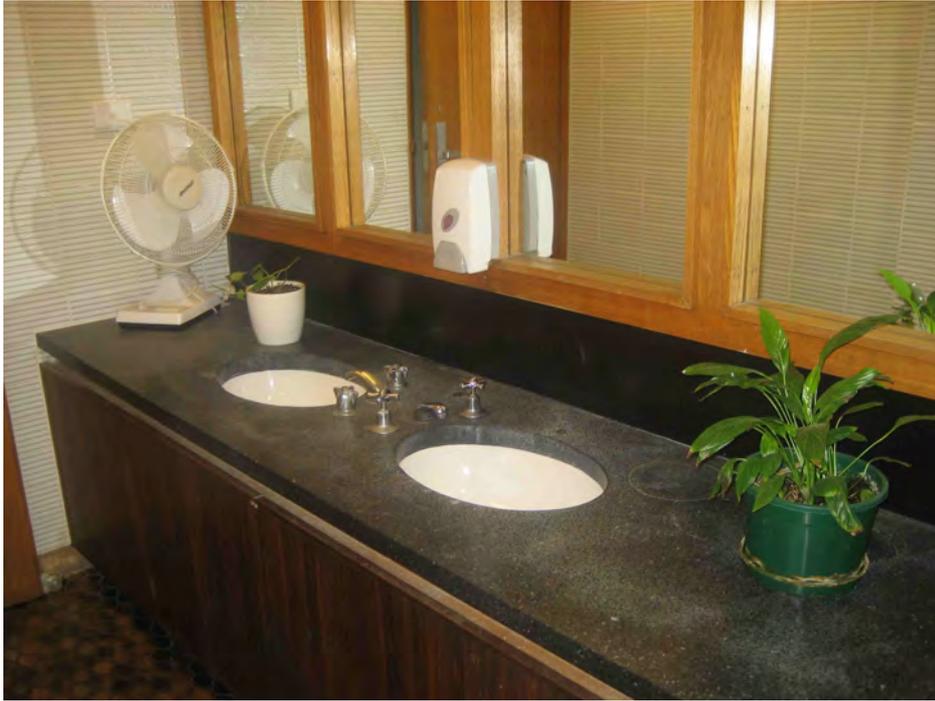
FIGURE 63 • The vanity in the staff and community room ladies' toilet is original • Source: Philip Leeson Architects.

The staff and community room ladies' toilet is virtually the only room in the library still in approximately original condition. There are ceramic tiles at the floor and the masonry walls are tiled to the ceiling. The ceiling is painted plasterboard. The door is solid core clear finished Ash timber with a door closer, door handle, a square Lockwood mortice latch set, and keypad entry lock. Above the door there is a panel of clear finished Ash timber to ceiling. There is an anodised aluminium double hung window with obscure glass, and the door and window jambs, cornice and window sill are clear finished Ash timber.

1. Clean tiles at upper part of walls and repair cracked tile in northwest corner.
2. Replace water damaged solid timber partition doors to match existing.
3. Refurbish original anodized aluminium double hung windows to address corrosion and sticking. If replacement is necessary, match existing as closely as possible.

1. Repair stains and apply seal to original terrazzo bench top.
2. Replace the non-original tap set to match the original as closely as possible.
3. Sand and refinish clear finished Ash trims, doors and sills.
4. Clean glazing at windows.

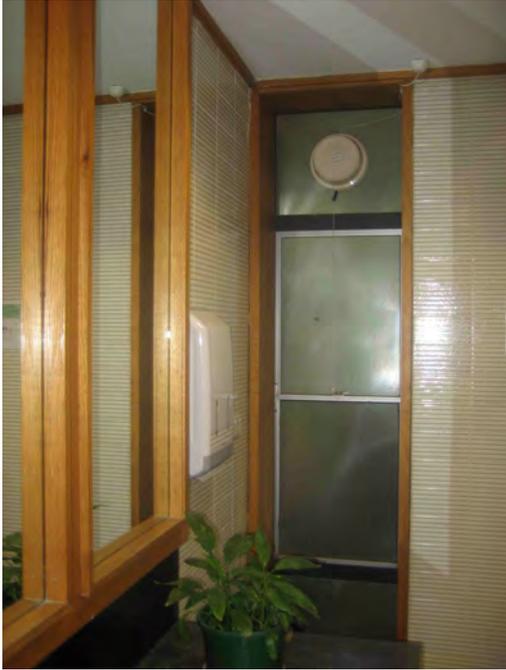
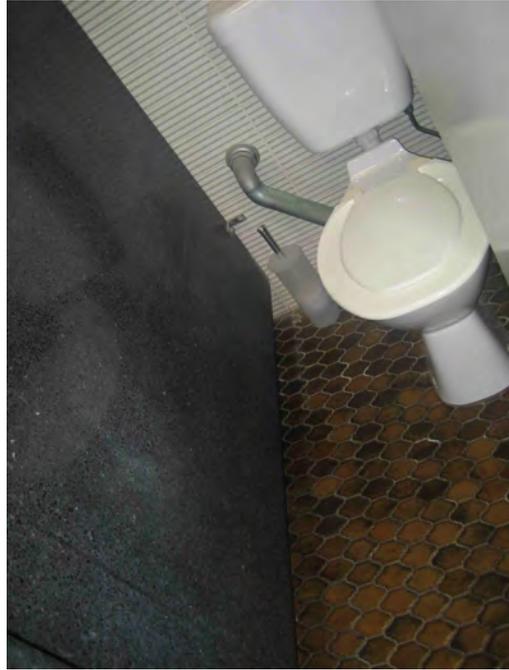
- New dual flush cisterns at toilets
- One basin tapset modified

FIGURES 64 & 65 • Original fitout including mirror and clear finished timber framing • Source: Philip Leeson Architects. • Original terrazzo toilet partitions between toilet pans • Source: Philip Leeson Architects.

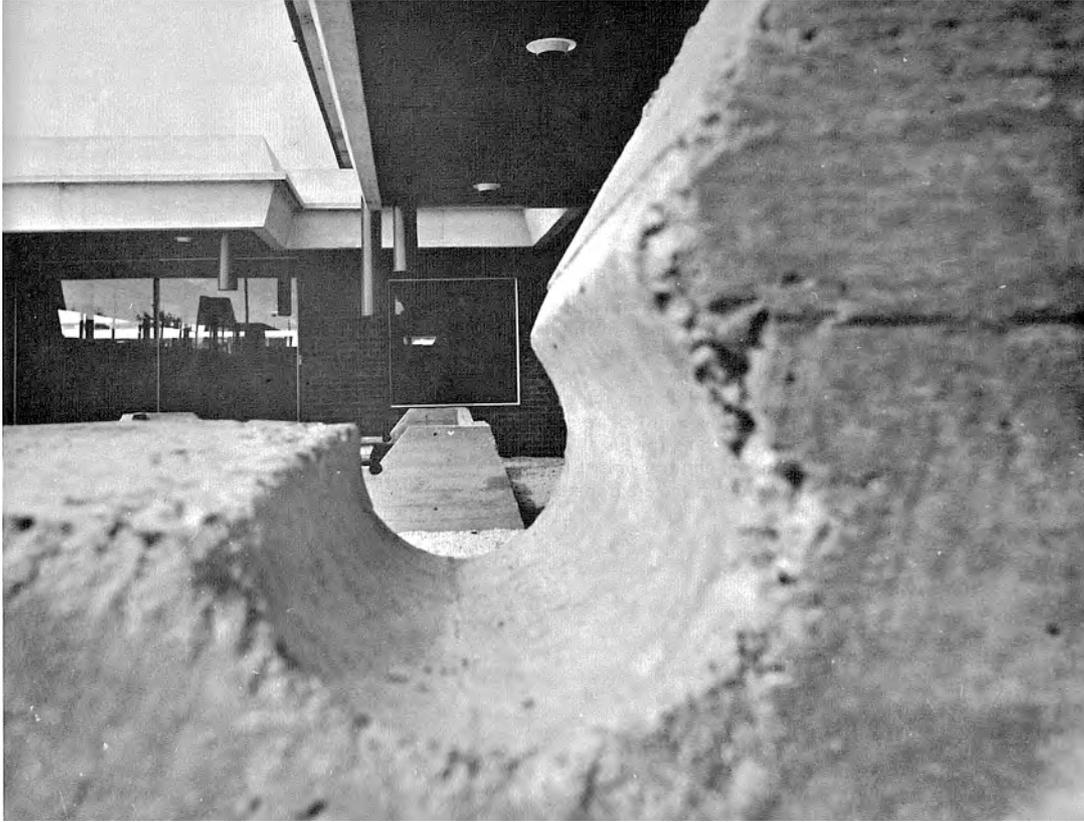
FIGURE 77 • The courtyards were designed with gravel at the ground plane, and with gloss red down pipes – a crisp landscape outlook and setting to the building. Note also the dark soffit lining and external light fittings. • Source: Enrico Taglietti.

- Replace the green colorbond fascias with unpainted fibre cement profiles to closely match the original innovative asbestos cement sheeting. Should fabrication prove prohibitively expensive replace or paint over the existing colorbond steel sheet in a colour which more closely approximates the original cement colour, eg. Shale Grey.

- Replace the ribbed cream colorbond sheet soffit lining with fibre cement sheeting painted to match the original dark colour.
- Re- paint the drainage pipes in the original primary red colour.

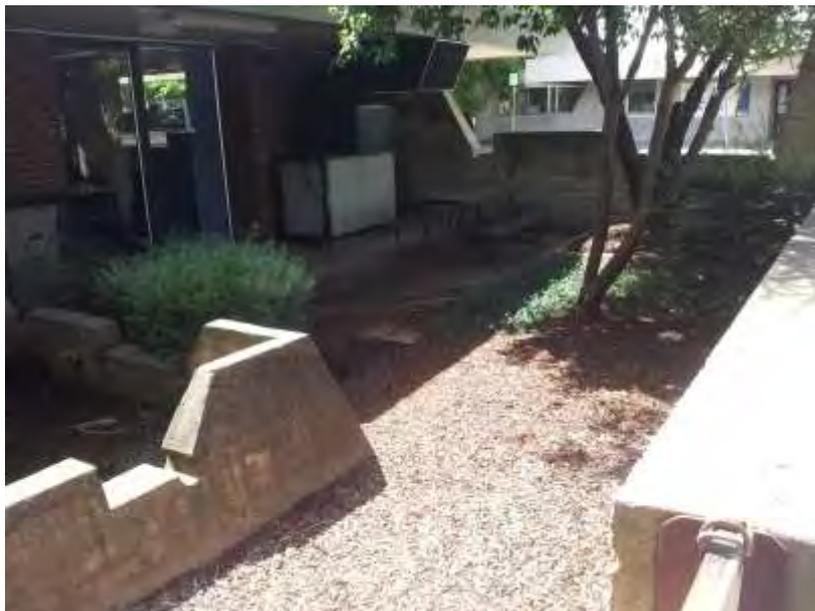
Intrusive mechanical plant

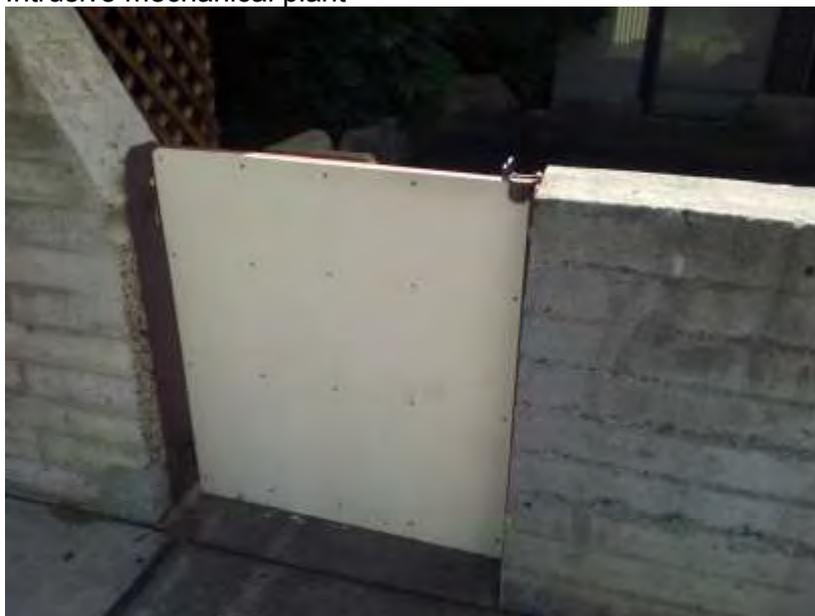
Insensitive insertion of gate including removal of off-form wall section.

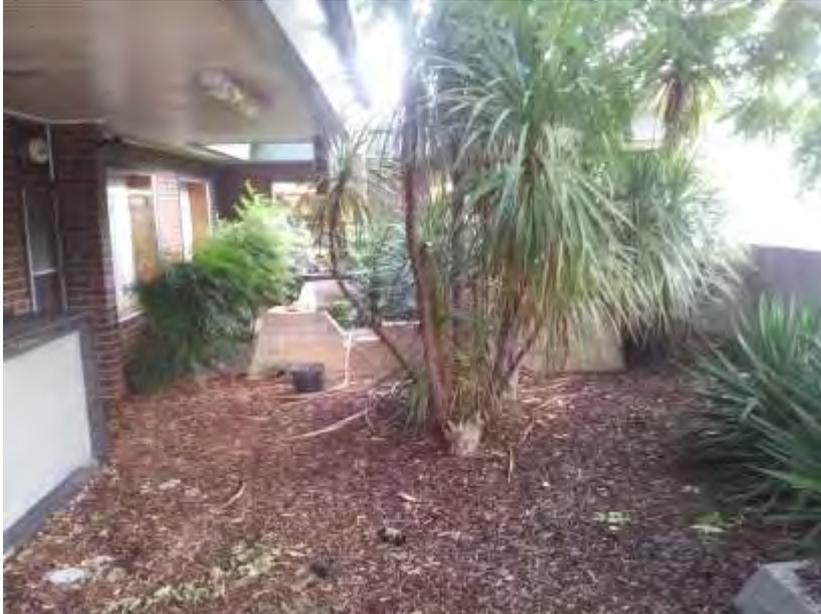
Cordyline australis – later planting

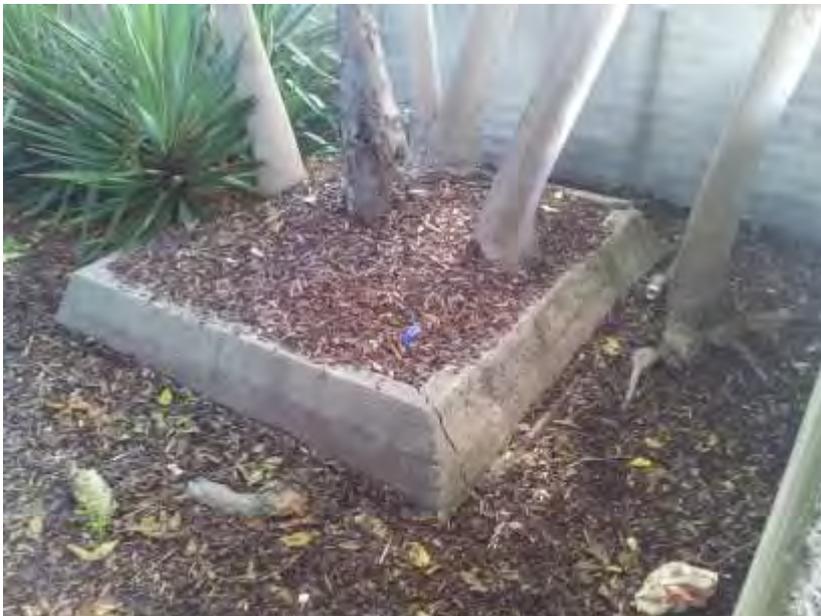
The Nandina is in good condition. The off-form concrete planter has cracked, due to the Ailanthus ssp. Suckers. The Cordyline australis, while a later planting, is a species consistent with landscape design style of the period (viz the southern façade of the ABC Radio building on Wakefield Avenue, Dickson).

Ailanthus suckers and crowding out the original Malus ssp.

- Infill /replace Nandina domestica;
- Remove pine bark mulch and replace with gravel or a combination of large-format precast concrete paver and decomposed gravel;
- Remove Ailanthus ssp. suckers adjacent to precast planter – remove poor quality Malus ssp. and replace with new stock.
- Remove mechanical plant – or provide a discreet screen softened by additional Nandina domestica plantings

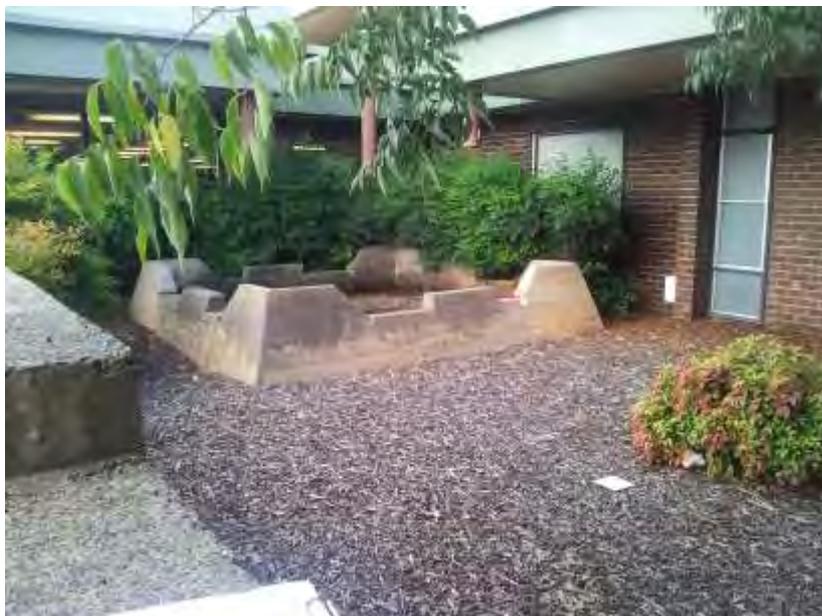
Bank of extant *Nandina domestica*

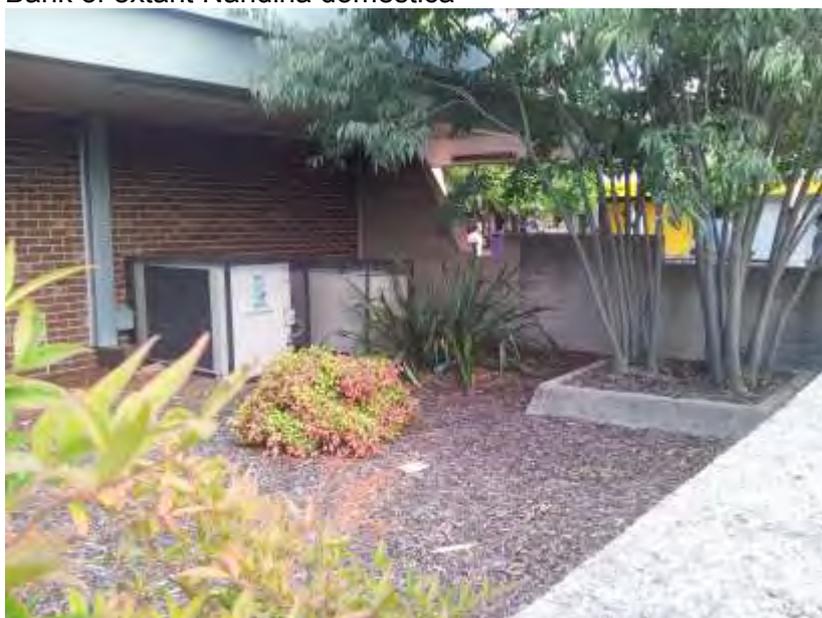
This courtyard has the best quality bank of *Nandina domestica*. The original *Malus* ssp. has died, the raised tree planter contains *Celtis australis* suckers.

Celtis suckers in raised tree planter

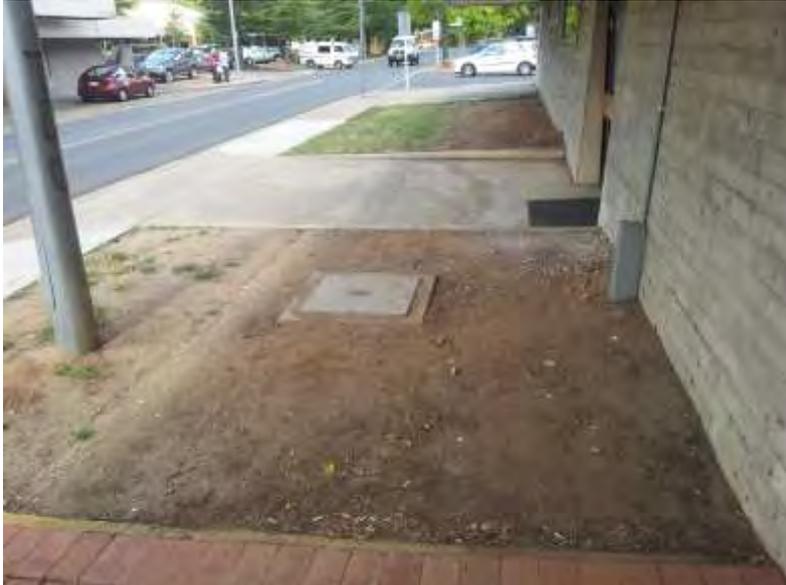
There is a service door access to the north. A portion of the verge is grassed. The grass has died/was never planted under the overhang. The original material may have been decomposed granite gravel?.

The current situation presents a safety hazard due to the loose surfaces. The loose surface has litter including cigarette butts and small pieces of general litter.

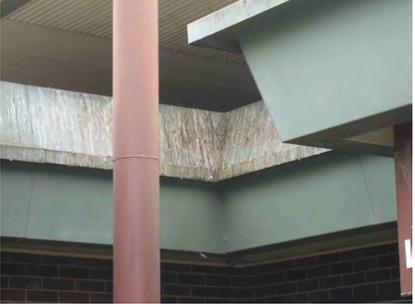
Important	Profiled metal fascias	Fix anti bird roosting devices to ledges

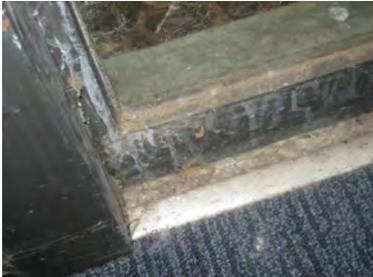
Important	Anodised aluminium windows	Several corroded and stuck shut. Overhaul to ensure smooth operation. If replacement required match existing as closely as possible.

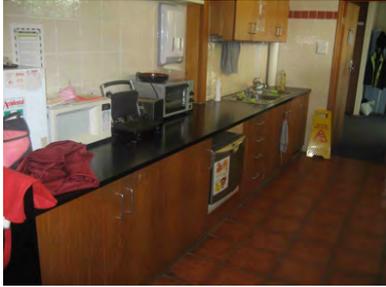
Important	Black laminate benchtop in Kitchen	Seal against wall	
Desirable	Unsympathetic elements in Kitchen	Provide adequate storage for kitchen appliances. Devise a more sympathetic storage arrangement for staff personal items and remove lockers.

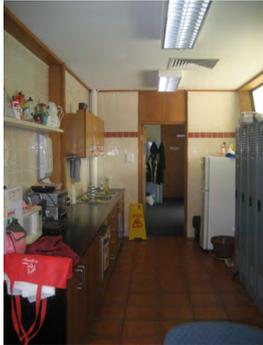
Important	Vent pipe in Kitchen	Repair poorly patched ceiling at penetration.

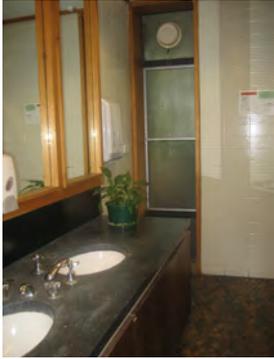
Desirable	Tapsets at Female Staff Toilet	Replace the non original set to match the original as closely as possible.
